DOT/FAA/AR-95/51

# Nondestructive Inspection of Piper PA-25 Forward Spar Fuselage Attachment Fitting

September 1995

Final Report

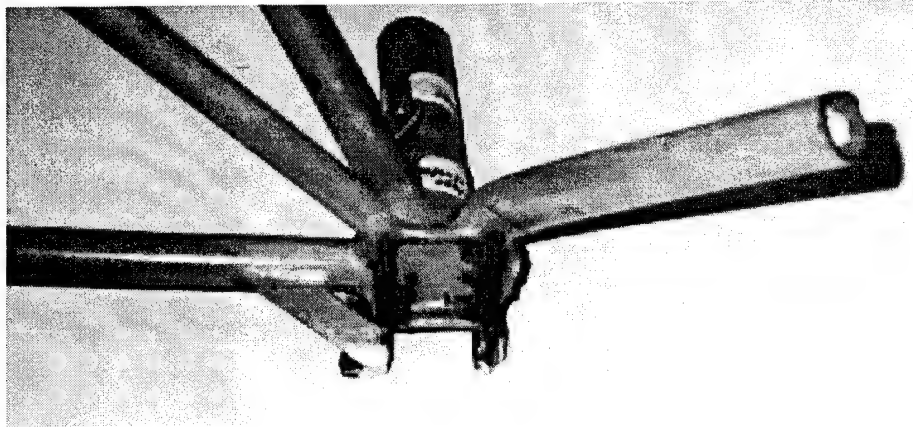
FIGURE 3. PICTURE OF THE FORWARD SPAR FUSELAGE ATTACHMENT CLUSTER CUT FROM AN ACCIDENT AIRPLANE IN ALABAMA.

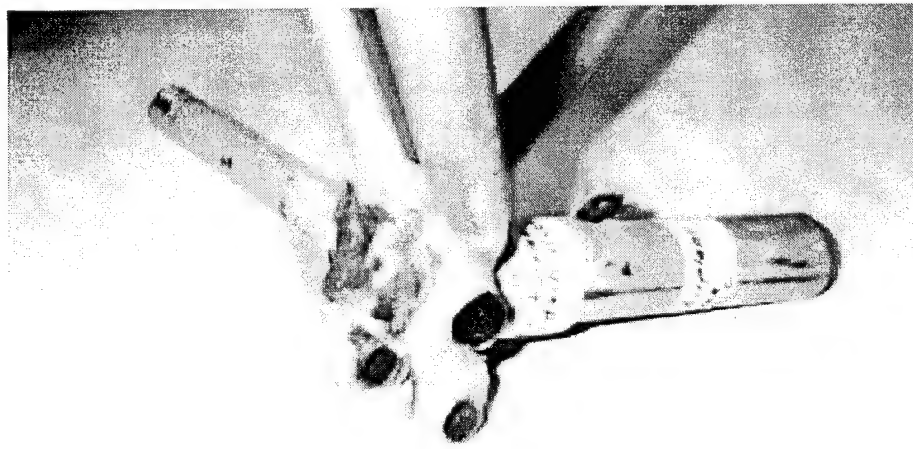
On May 21, 1993, an in-flight separation of the wing from a Piper PA-25 airplane occurred. The investigation of the affected airplane revealed corrosion and cracks in the forward spar fuselage attachment fittings. The forward spar fuselage attachment fitting consists of a clevis ear welded to a 4130 steel tube forward spar as illustrated in figures 1 and 2. This welded metal interface fractured at the base of the clevis ear. Extensive corrosion was found at the fracture site. Further review revealed that a strong oxidation layer between the two welded sections of the fitting assembly (washer and ear flange) had occurred over a long period of time. Figures 3 and 4 are photographs showing the corroded spar fuselage attachment. This airplane was used for agricultural crop dusting and had accumulated over 5,000 hours time in service (TIS) at the time of the accident. A similar accident had occurred previously on September 21, 1991, to an airplane with 10,000 hours TIS. These two different accidents alerted the FAA that an unsafe condition may exist on the Piper Model PA-25. The FAA also believes that airplanes utilized in agricultural environments are extremely susceptible to the above corrosion conditions.

FIGURE 4. SIDE VIEW OF FIGURE 3 THAT DISPLAYS THE EXTENSIVE CORROSION OF THE FITTING EARS.

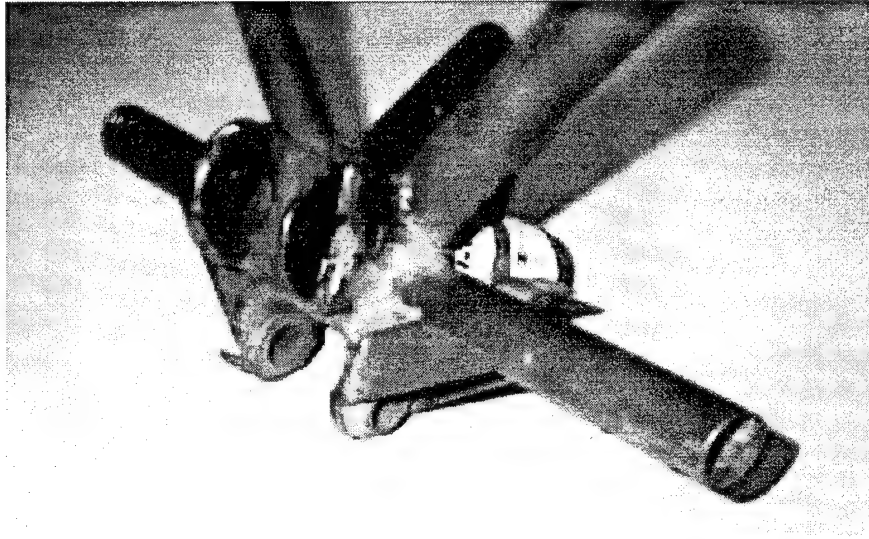
corrosion on both ear fittings. Half of one ear was removed by a bandsaw to reveal the inner layer corrosion shown in figure 6. Sample 3 was a forward spar fuselage attachment cluster used as a blind sample to develop the inspection techniques. It was not known if corrosion existed between the inner layers. Sample 3 is shown in figure 7. The AANC staff performed both radiography and ultrasonic inspections on the spar cluster assembly. Test setup, calibration, and inspection techniques are described, and findings from each technique are stated.

The gap between the washer and ear flange was measured to be between 0.015 to 0.025 inch for the corroded sample 2. The standard design tolerance for this gap, however, was unknown so an assessment of the corrosion thinning could not be made. Cracks in the inside tube diameter of sample 2 could not be detected. Alignment between the x-ray source and the spar cluster would be critical if this technique was used to find cracks in the tubing. For this application, radiography would not be reliable in finding cracks in the tubing without conducting several exposures at different orientations.

FIGURE 6. SAMPLE 2 - FORWARD SPAR FUSELAGE TUBULAR ATTACHMENT CLUSTER FROM A PA-25 AIRPLANE. NOTE: HALF OF ONE EAR WAS REMOVED BY A BAND SAW. THE DARKER AREA IS CORROSION.

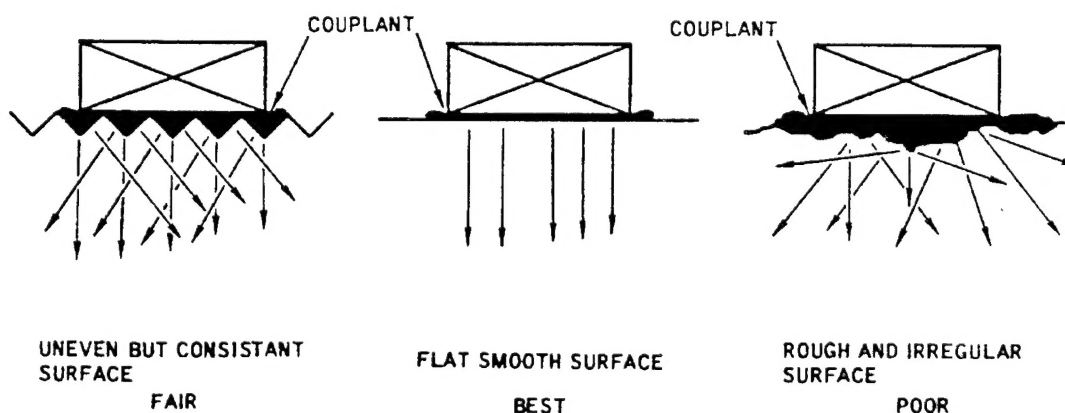
The test setup was then applied on the surface corroded sample 2. The thickness of sample 2 could not be determined. The instrument sensitivity (gain) was increased and the backwall echo still could not be detected. The problems with sample 2 were due to the rough outer surface of the test sample. Figure 11 illustrates the undesirable effect of surface roughness on the distortion of ultrasonic wave propagation. This probe and technique were abandoned.

FIGURE 11. ILLUSTRATION OF THE UNDESIRABLE EFFECT OF DISTORTION OF WAVE DIRECTIVITY DUE TO THE SURFACE OF THE TEST SPECIMEN AND HOW IT CAN GREATLY AFFECT ULTRASONIC WAVE PROPAGATION.
